1. Why do I want to study Oyster shell ?

Material

Methodology

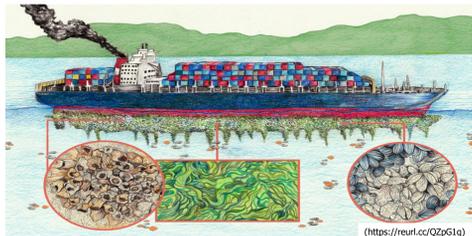
Tributyltin (TBT) is an organotin compound. It's used to prevent organism growth on boat hulls (Fig. 2). TBT is a significant aquatic pollutant due to its use in marine paint. The global ban on TBT in boats happened in 2008, with Taiwan enforcing it in 2005 (Table 1).

Fig. 2. In the absence of TBT usage, the hull tends to accumulate a multitude of organisms.

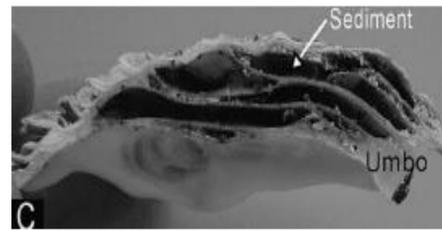
Fig. 3. The STI of *C. gigas* falls between 5 and 10, and it still possesses chambers.

TBT pollution leads to chambering, causing shells to become fragile and exhibit abnormal characteristics. It's noteworthy that a higher concentration of TBT correlates with a lower STI value (Table 2). This can be quantified using the Shell Thickness Index (STI).

Shell Thickness Index (STI) $STI=L/T$

(L: Length of the left valve; T: Thickness of the left valve)

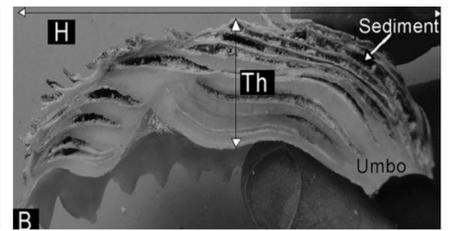
Fig. 4. The STI of *C. gigas* less than 5, it possesses many chambers.

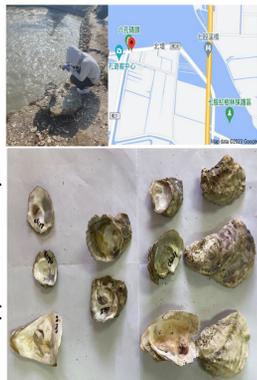
The sampling point of this experiment is Qigu, Tainan. As the closest land breeding area, it is easily affected by changes in land nutrients (Fig. 5).

Fig. 5. The total samples and Qigu, Tainan.

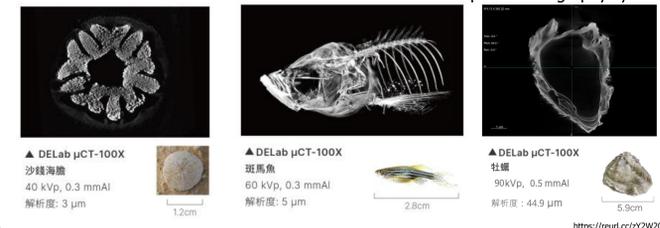
Fig. 7. Principle of the micro-computed tomography system.

2. The Micro-CT principle is to shine X-rays on the sample, and then the sample rotates 360 degrees on the stage to capture images of the object (Fig. 7).

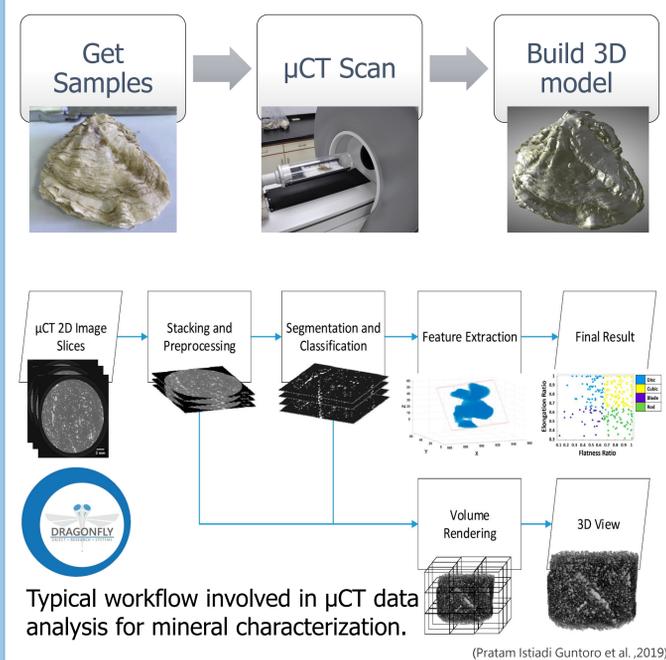
Typical workflow involved in μCT data analysis for mineral characterization.

2. Dragonfly ORS

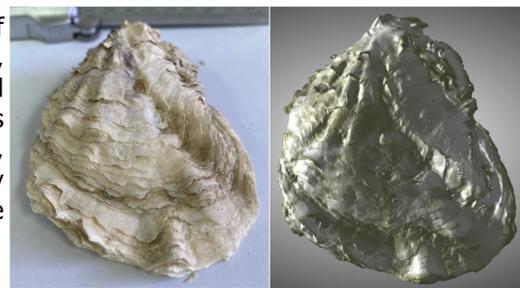
Fig. 8. The oyster sample.

Fig. 9. The oyster's shell.

In the Chi 2 sample, distinct characteristics of the reconstructed shell have become apparent, including fold ribs (Fig. 8,9). Our initial observations suggest that the Shell Thickness Index (STI) falls within the range of 5 to 10, and the internal voids within the shell primarily consist of wormholes rather than genuine chambers (Fig. 10, 11, 12).

Sample ID	Length (mm)	Width (mm)	Height (mm) Max-1	Max-2	Max-3	Height (mm) Min-1	Min-2	Min-3	Height (mm) Max average	Height (mm) Min average	standard error (max)	standard error (Min)	STI
chi2	84.77	59.17	10.56	11.25	12.83	2.09	1.92	2.62	11.55	2.21	1.16	0.37	7.34

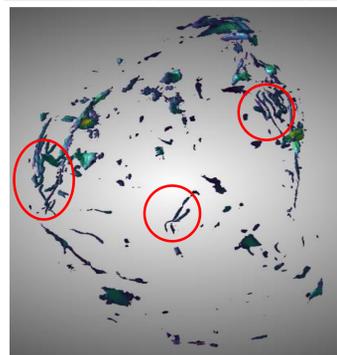
Fig. 10. The oyster's chambers.

1. The STI index is applicable for non destructive 3D micro CT analysis.
2. The chambering of Chi2 are dominantly caused by worm holes instead of TBT pollution.

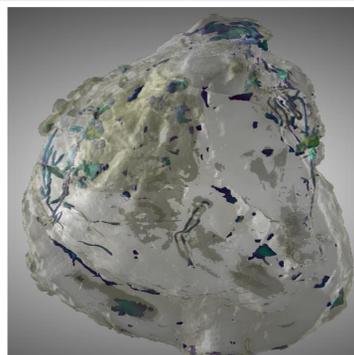
Fig. 11. The oyster's chambers with shell.

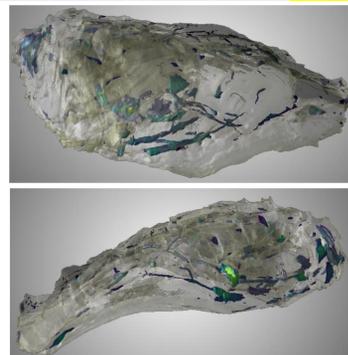
Fig. 12. both sides of the oyster's shelled chambers.

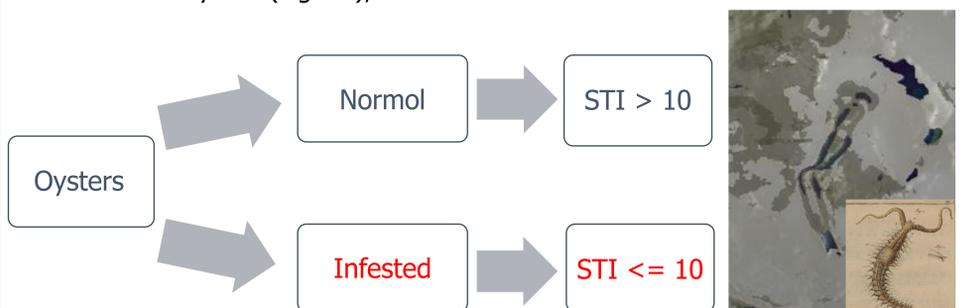
Fig. 13. *Polydora* and wormhole.

In previous articles, I came across information that suggests when oysters are infested with *Polydora* (Fig. 13), their STI values tend to be less than 10.
